Sample Name : Epico Silicone Magnetic-Magsafe Compatible Case
SGS Ref No. : CP21-069663
Date of Receipt : 2021-12-29
Testing Start Date : 2021-12-29
Testing End Date : 2022-01-05
Test Result(s) : For further details, please refer to the following page(s)

1. Test Item: Free Drop Test

Test Standards: Refer to MIL-STD-810H:2019.

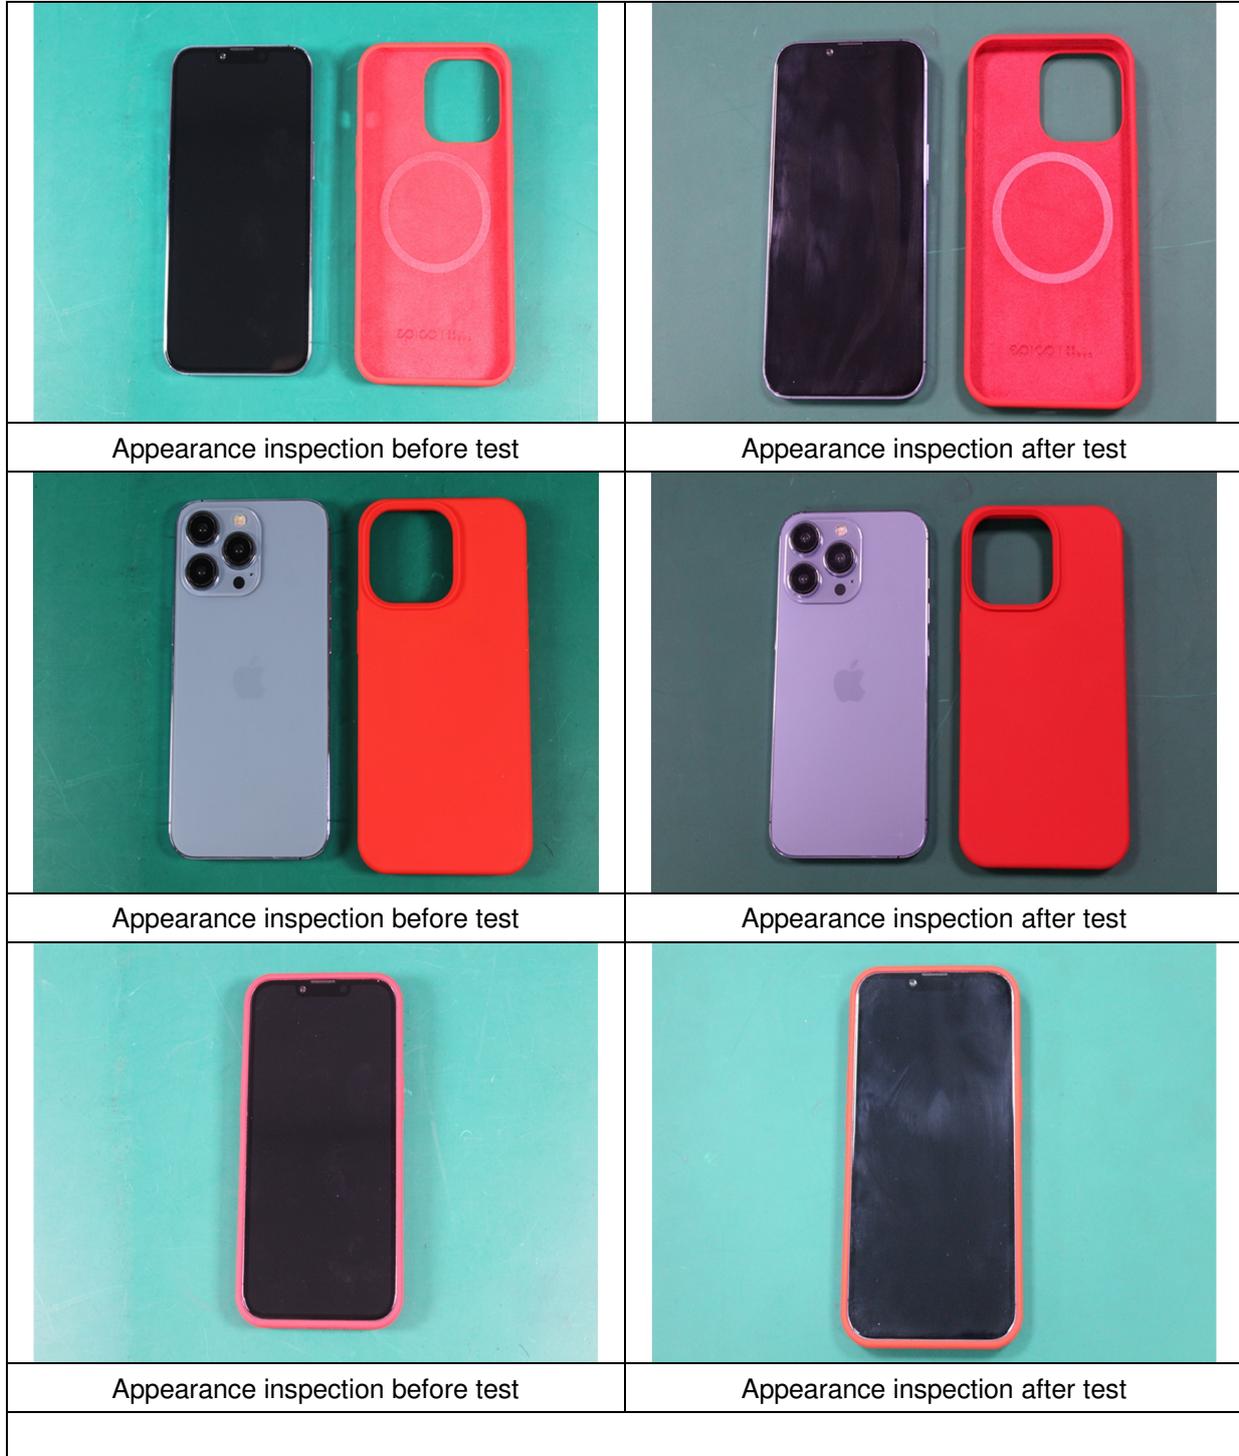
Test Photos:

- Sample Status: Unpackaged
- Drop Height: 1200 mm
- Floor Height: 30 mm
- Adjusted Height: 1230 mm
- Drop Times: 26 times (6 faces, 8 corners, 12 edges)
- Drop Surface: Hardwood

Sample No.	Appearance Inspection		Conclusion
	Before Test	After Test	
1# (Phone case)	No visible damage	No damage and crack	Pass
1# (Mobile phone)	No visible damage	No damage and crack

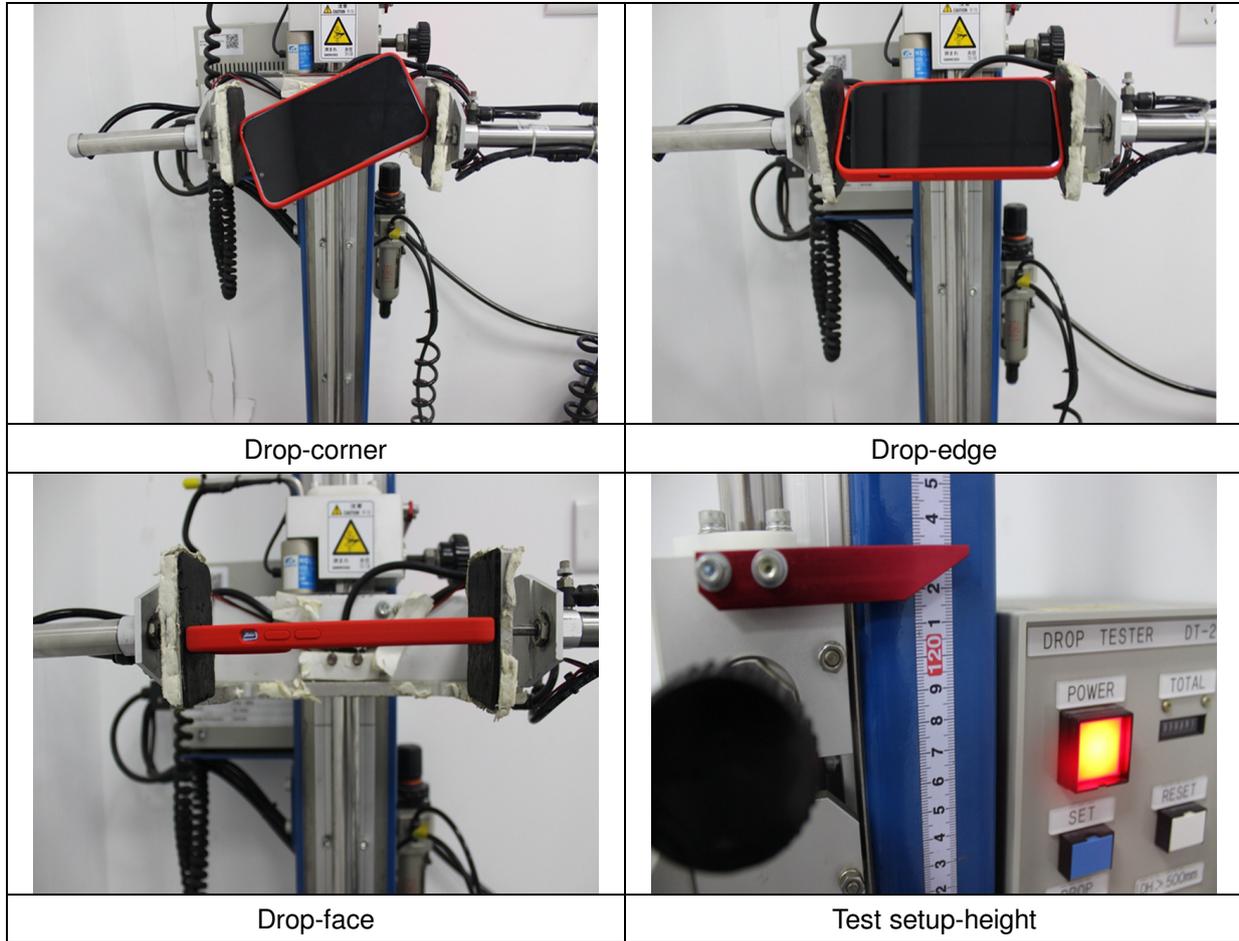
Drop-corner

Drop-edge

Drop-face

Test setup-height
